ESL-TR-91-13
VOL II

**EXPEDIENT REPAIR OF STRUCTURAL
FACILITIES (ERSF) - VOLUME II: ERSF
SYSTEM REQUIREMENTS AND USERS
GUIDE**

JULY 1991

FINAL REPORT

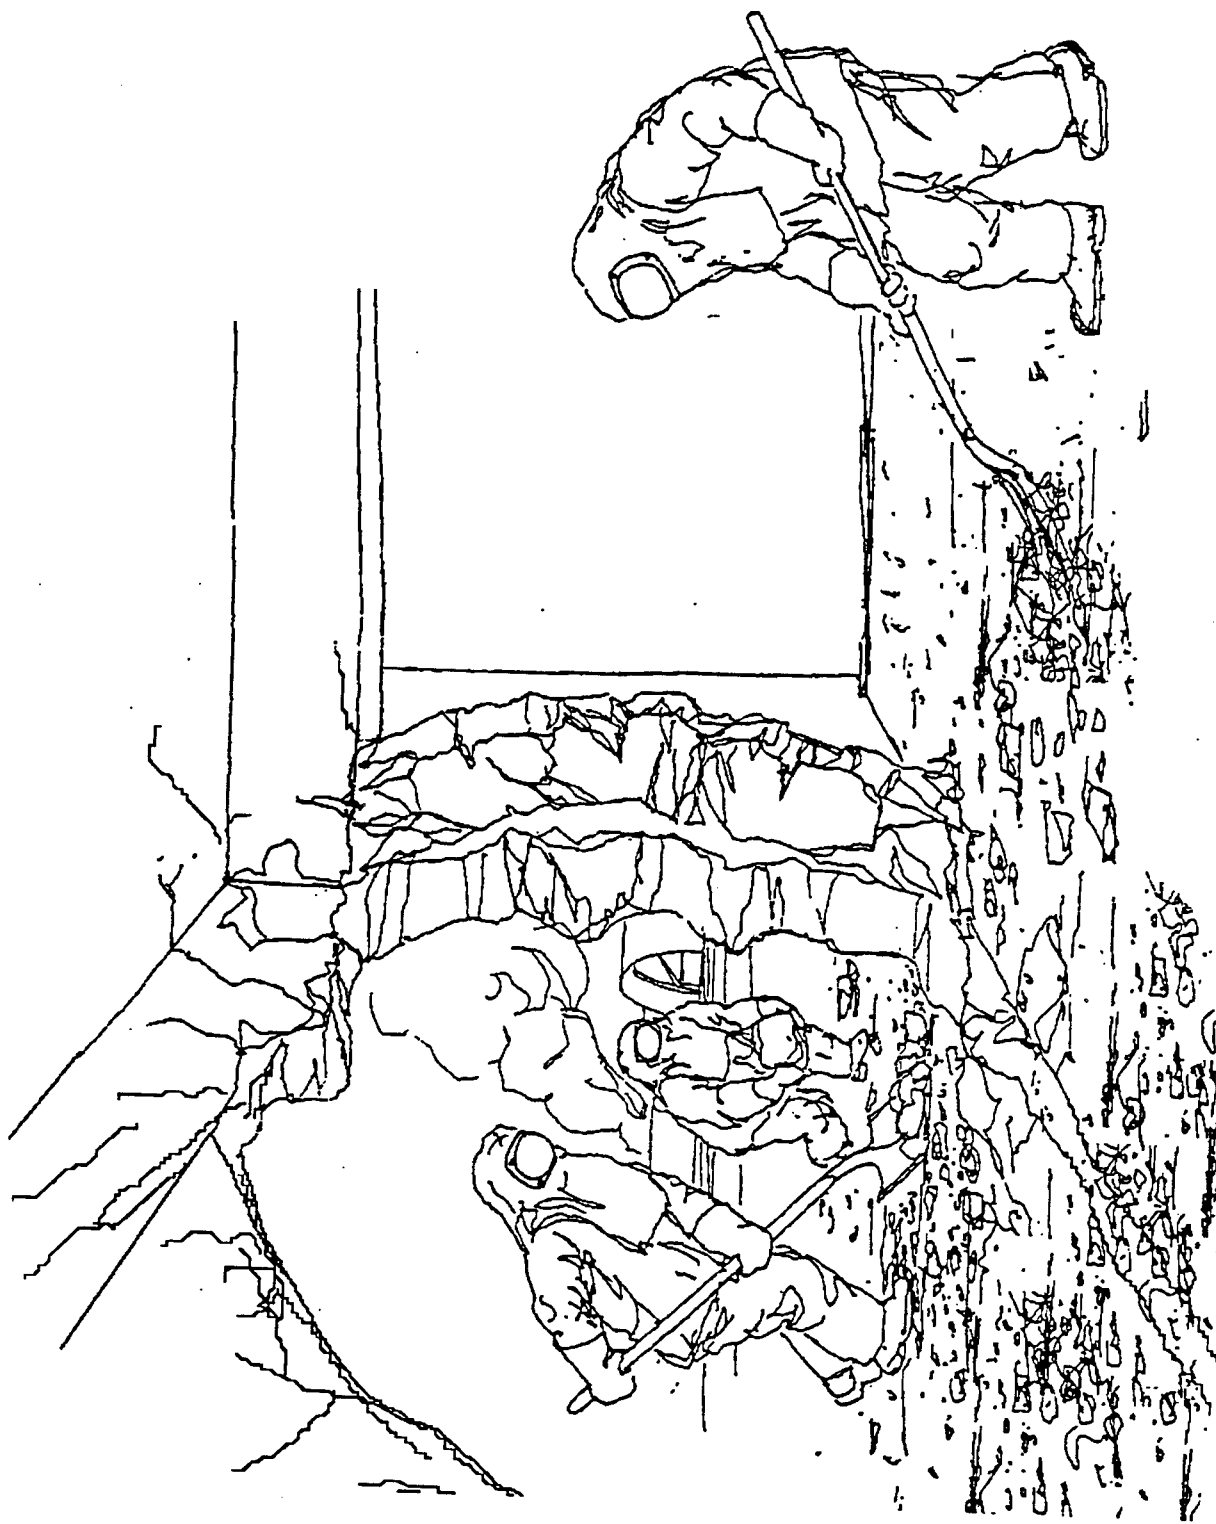
Figure 2. Debris Clearance During Column Replacement.

Figures 2 through 5 show a method for replacing a badly damaged reinforced concrete column. After clearing away debris and other interfering, non-load-bearing structural material from around the column, a shoring jack is placed beside the damaged column, then extended until its capacity is reached or repair personnel can no longer extend it, whichever occurs first. Then a glued, laminated timber (glulam) column, trimmed to the correct length, is positioned and wedged next to the jack. A 10-foot long, 12-inch square glulam column should provide sufficient capacity, while still being relatively easy to handle. The capacity of such a column is discussed in Section VI. The glulam column is braced laterally with lumber for stability, and the jack removed to be reused elsewhere, leaving the glulam column to carry the vertical load.

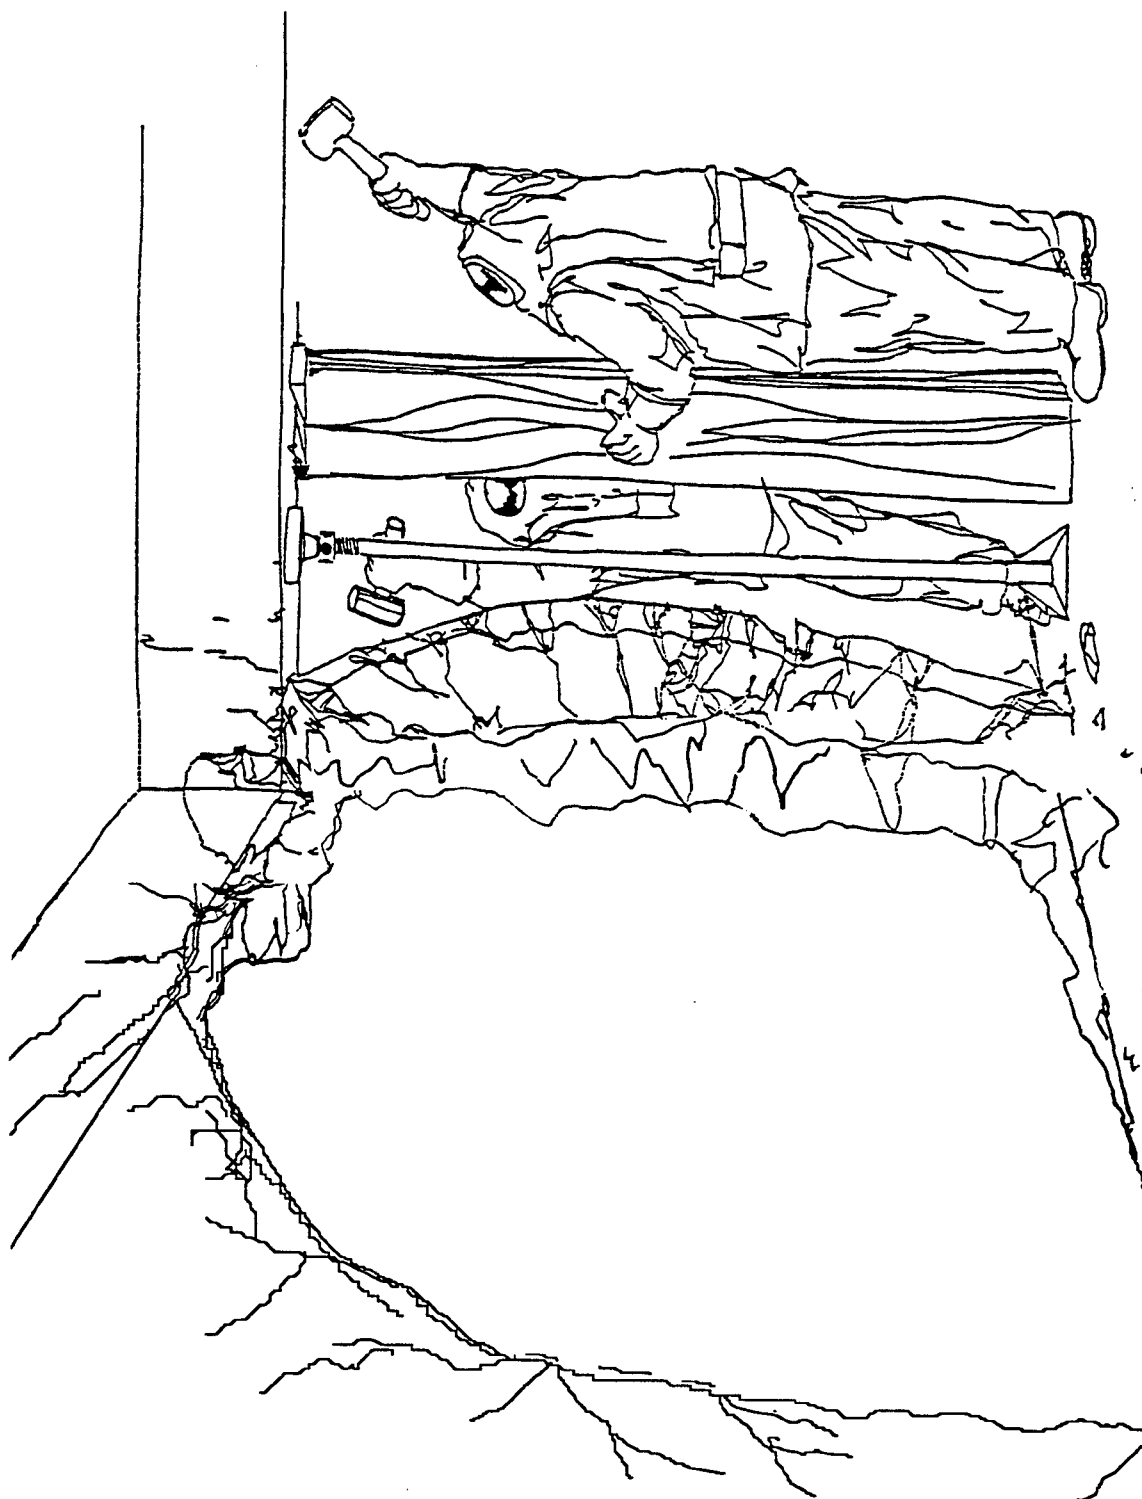
Figure 4. Column Insertion During Column Replacement.

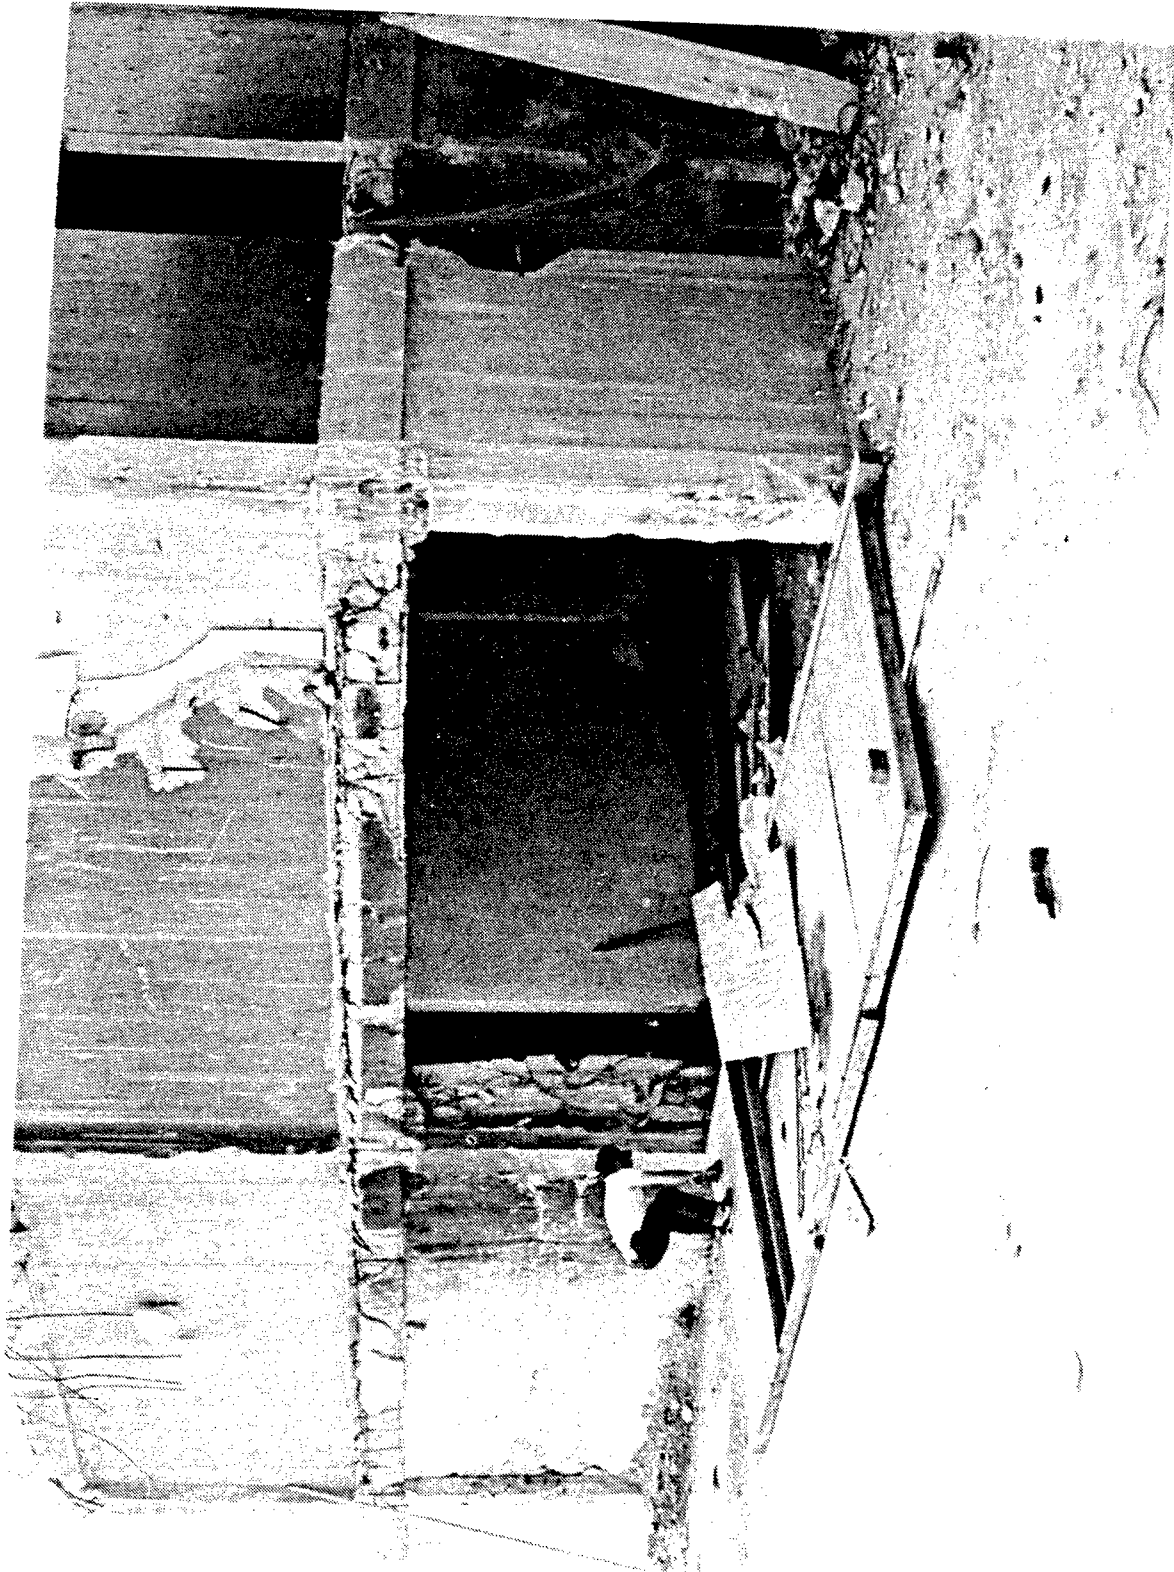
Figure 14. Destroyed Reinforced Concrete Wall.

In this damage mode, a non-load-bearing, reinforced concrete or masonry block wall has been completely destroyed, with only minimal portions of the wall remaining attached to the surrounding columns and floor or roof beams. An example of such a wall is shown in Figure 14. Candidate expedient repair methods for such a damage mode are described below.

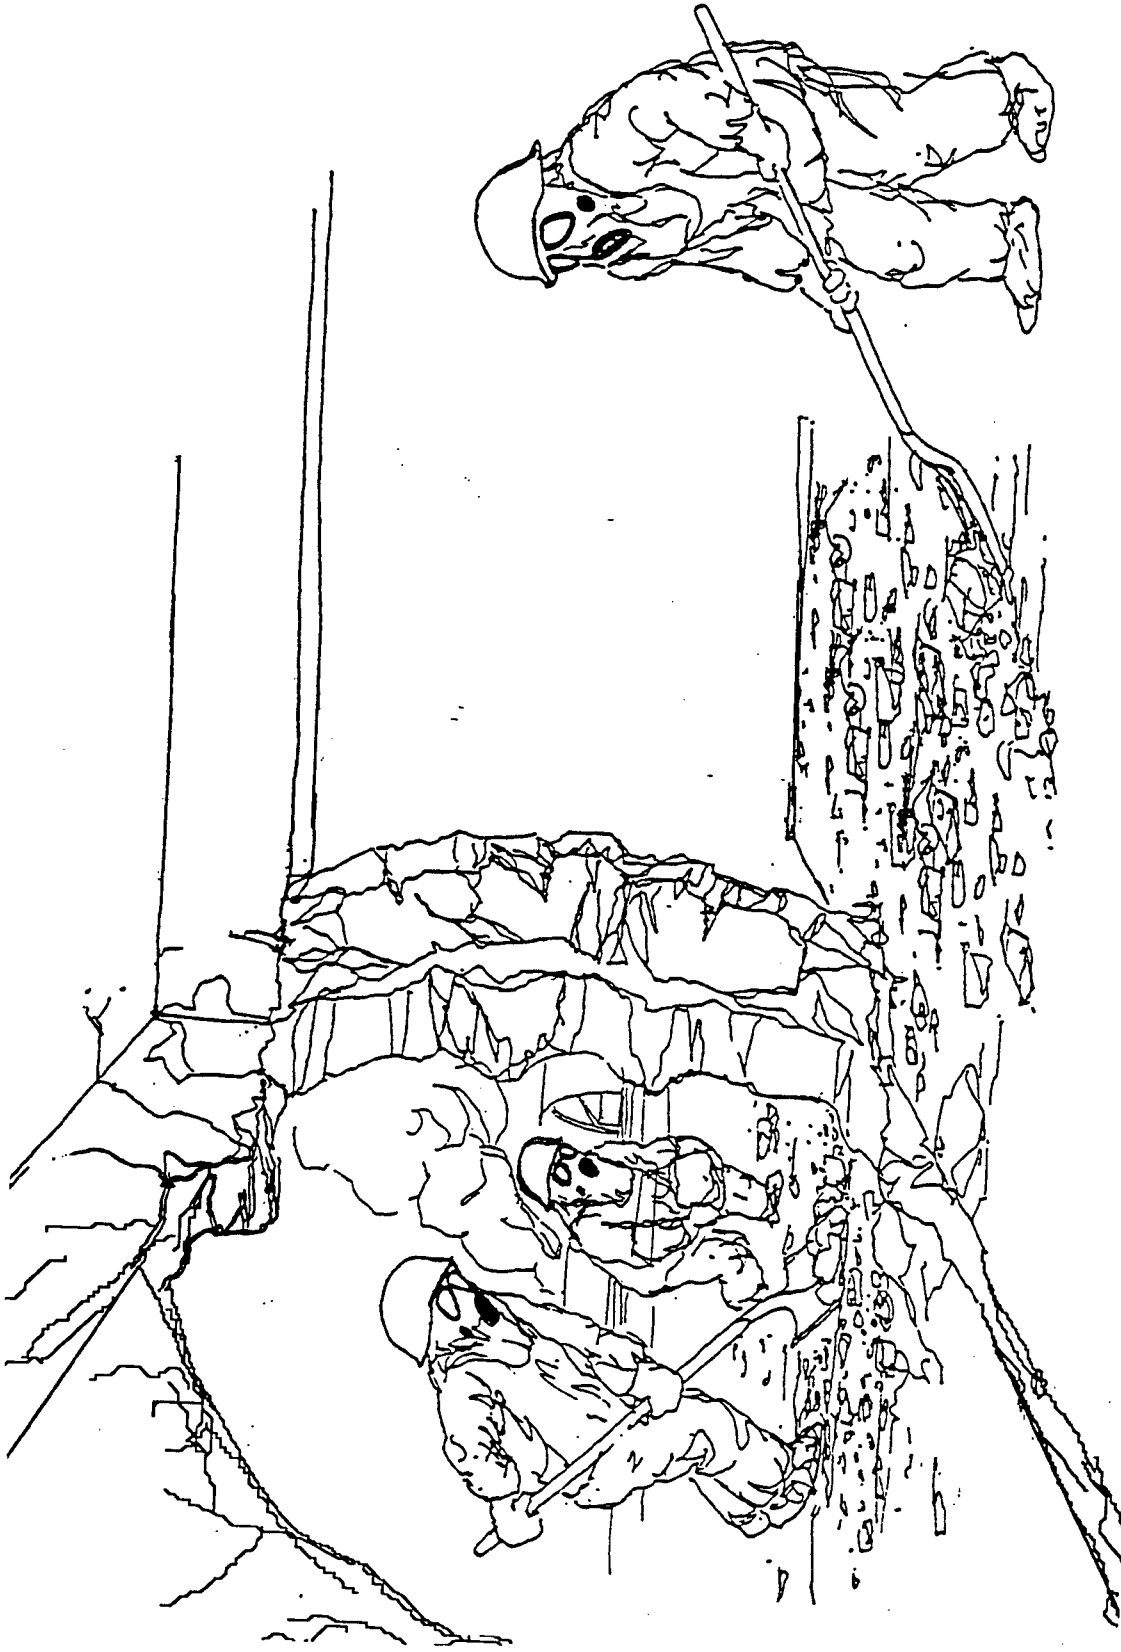
Figure 15. Debris Clearance During Shotcrete Wall Replacement.

In this repair, a rapid-setting, high-strength, steel-fiber-reinforced, dry-mixed shotcrete material developed by AFESC/RD's materials branch (AFESC/RDCM) is used to replace the destroyed wall as shown in concept in Figures 15 through 17. Development of this material is described in Reference 18. A general discussion of shotcrete, including expedient repair concepts with the material, are given in Reference 19.

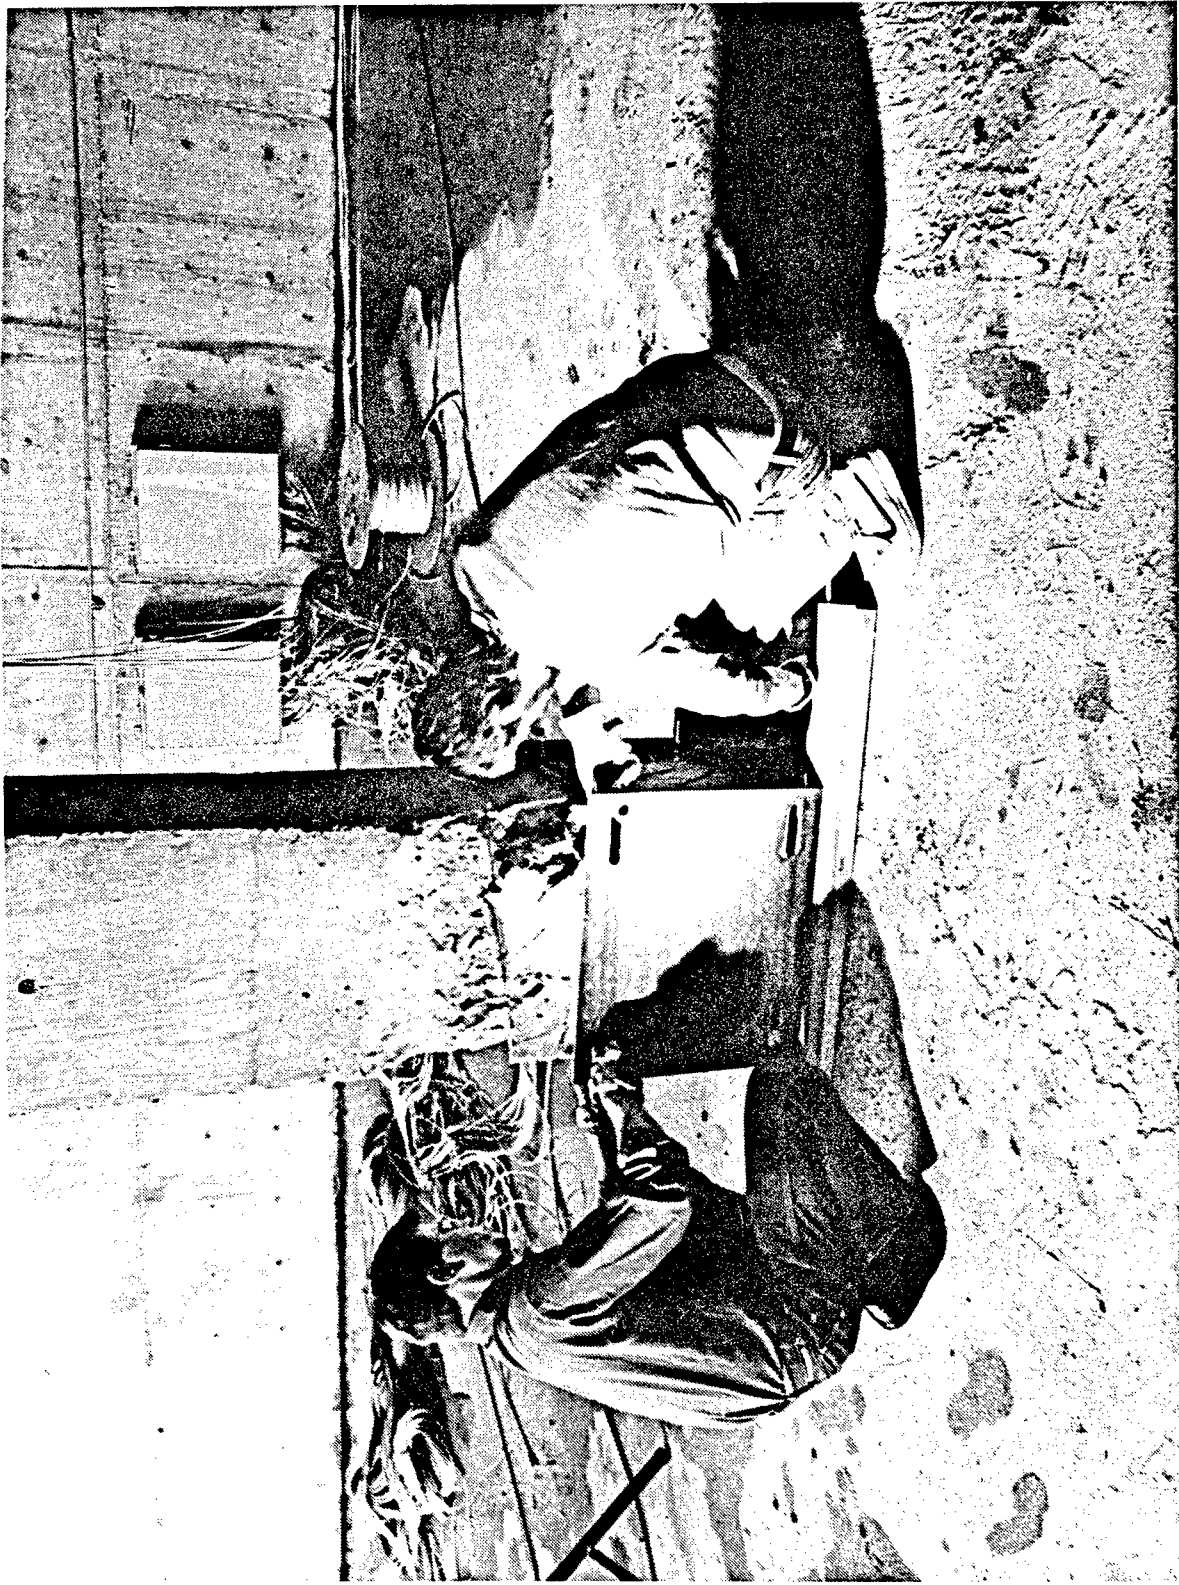
Figure 37. Positioning Splint Plates at the Bottom of the Column.

In general, the splinting process was accomplished as follows. The splint plates, with chains preattached to one plate with nuts and bolts, were positioned at the correct height on the column, as shown in Figure 37 (bottom of column) and Figure 38 (4 feet high on column). At the 4-foot height, rope was used to bind the two-by-fours to two sides of the column. The chains were then connected to the other plate with nuts and bolts, as shown in Figure 39, then tightened to clamp both plates to the column. The chain tightening process is shown in Figure 40.

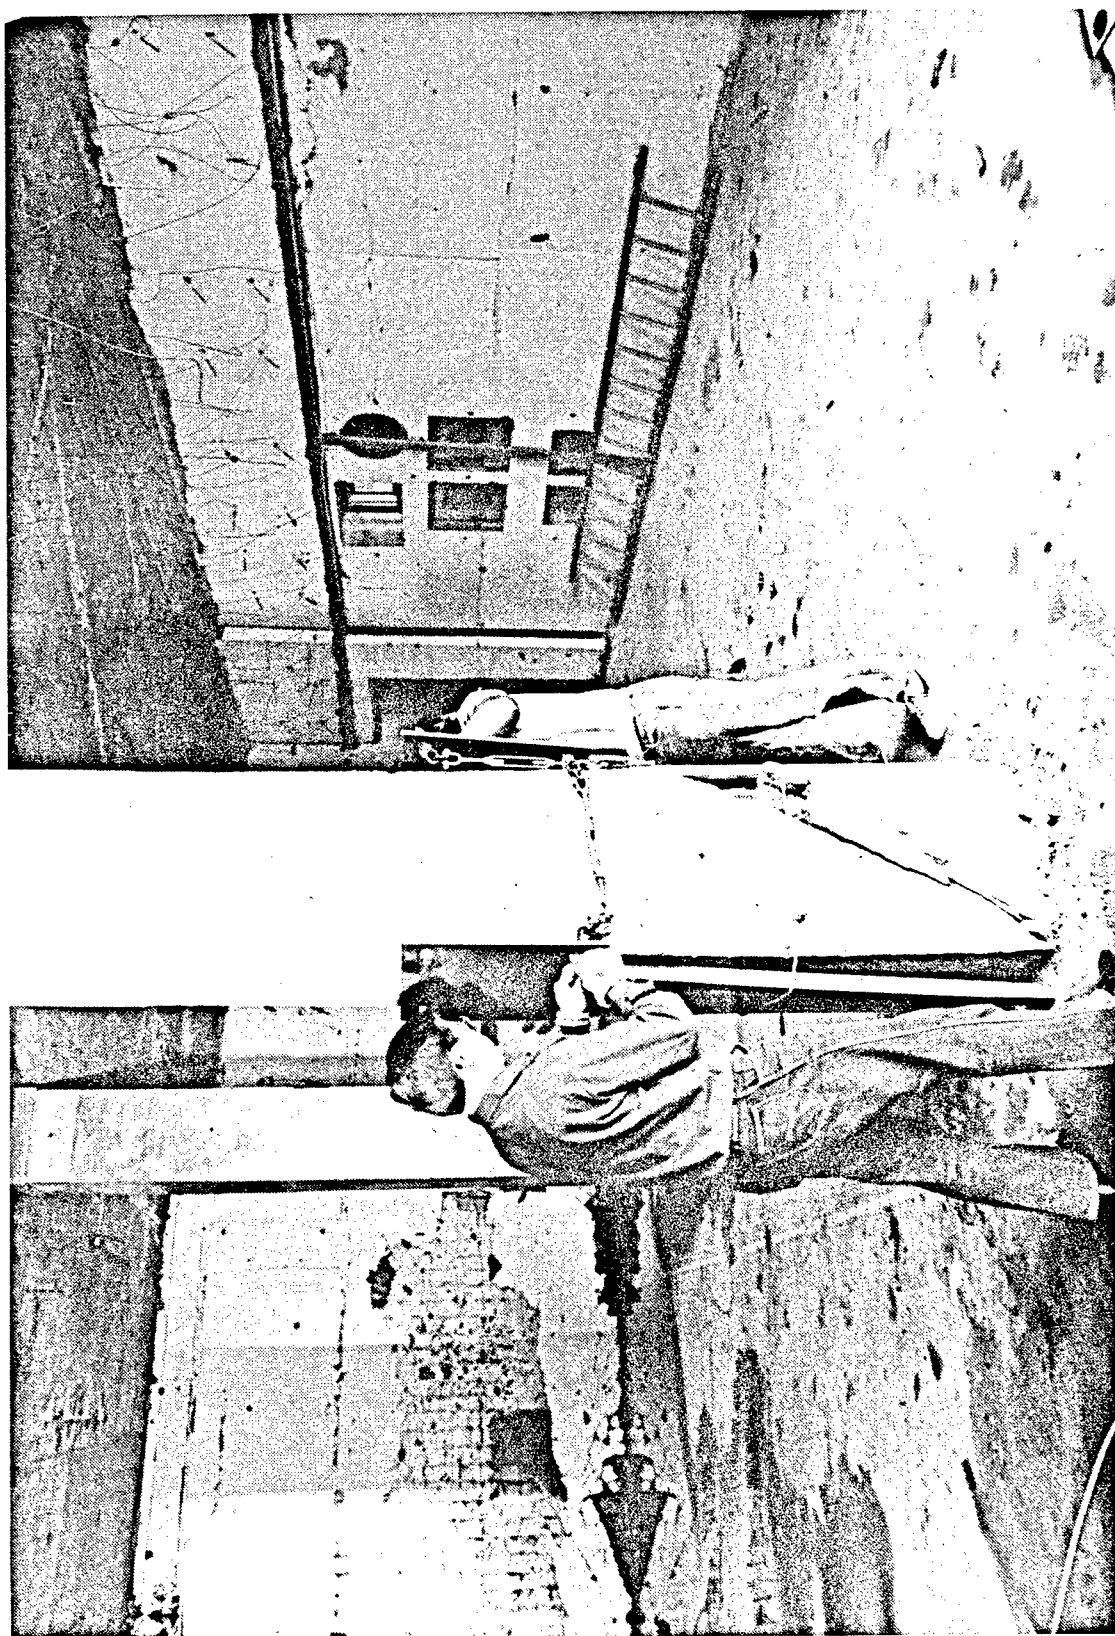
Figure 38. Positioning Splint Plates 4 Feet High On the Column.

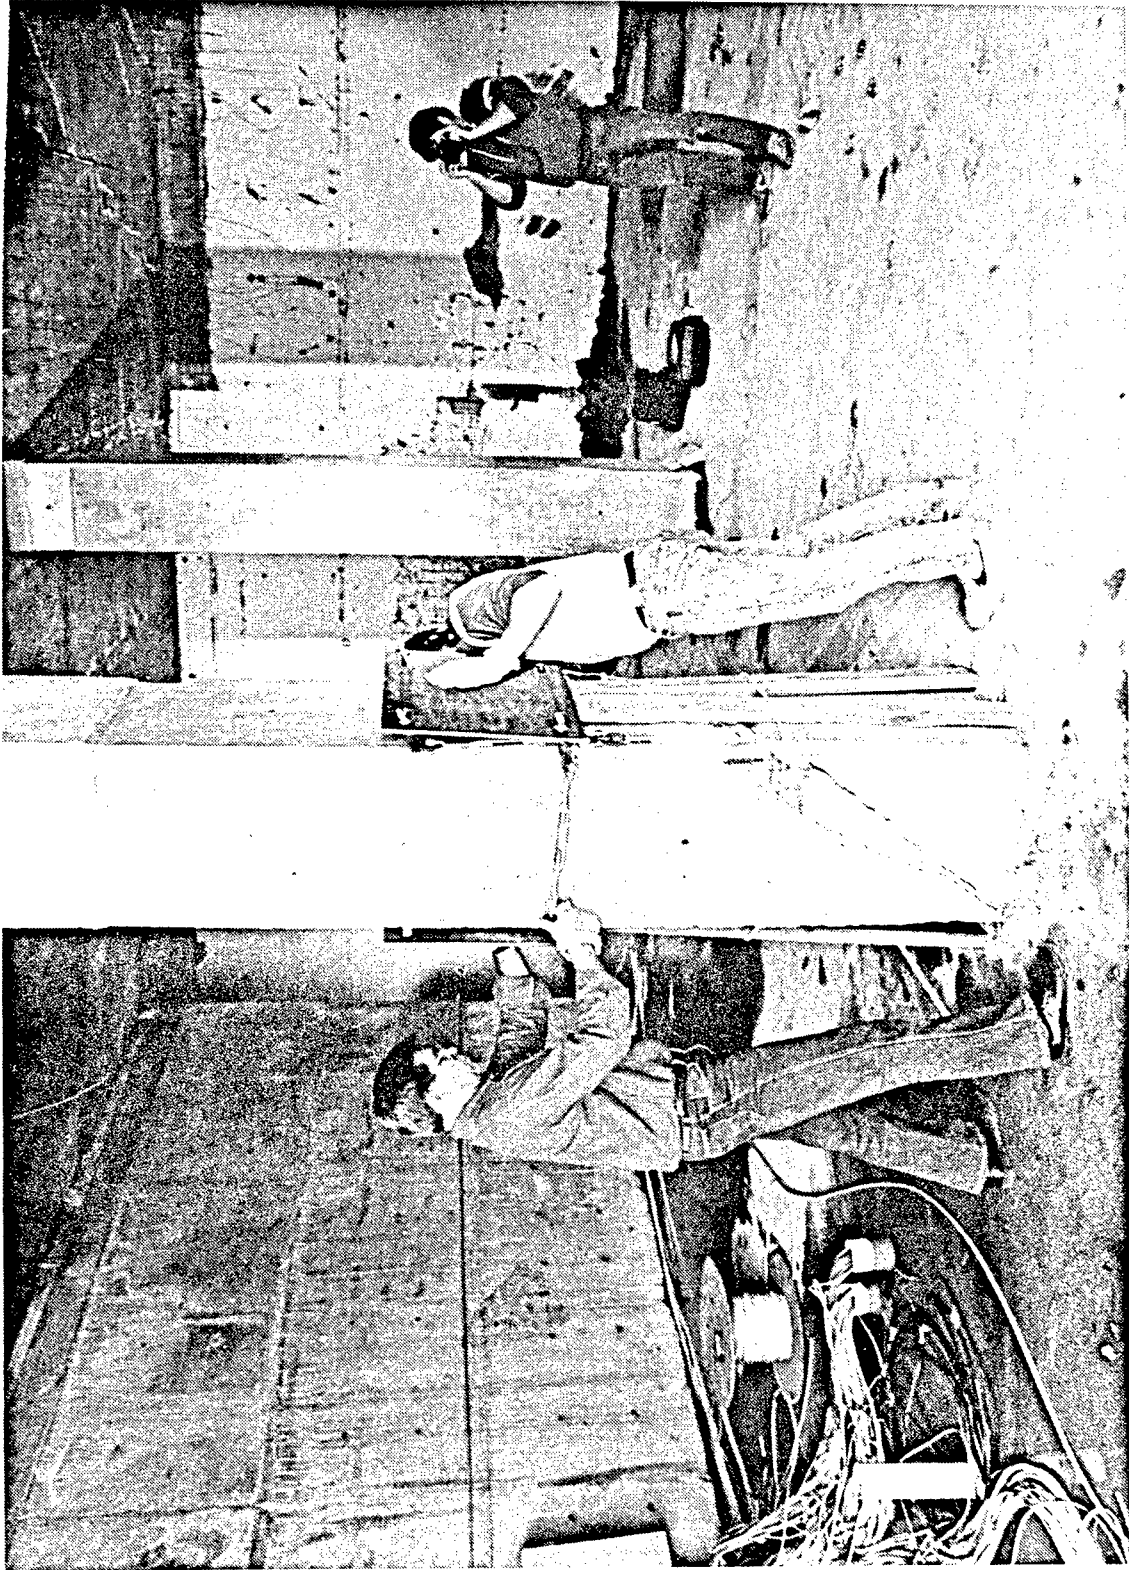
Figure 39. Placing Splint Chains Around the Column.

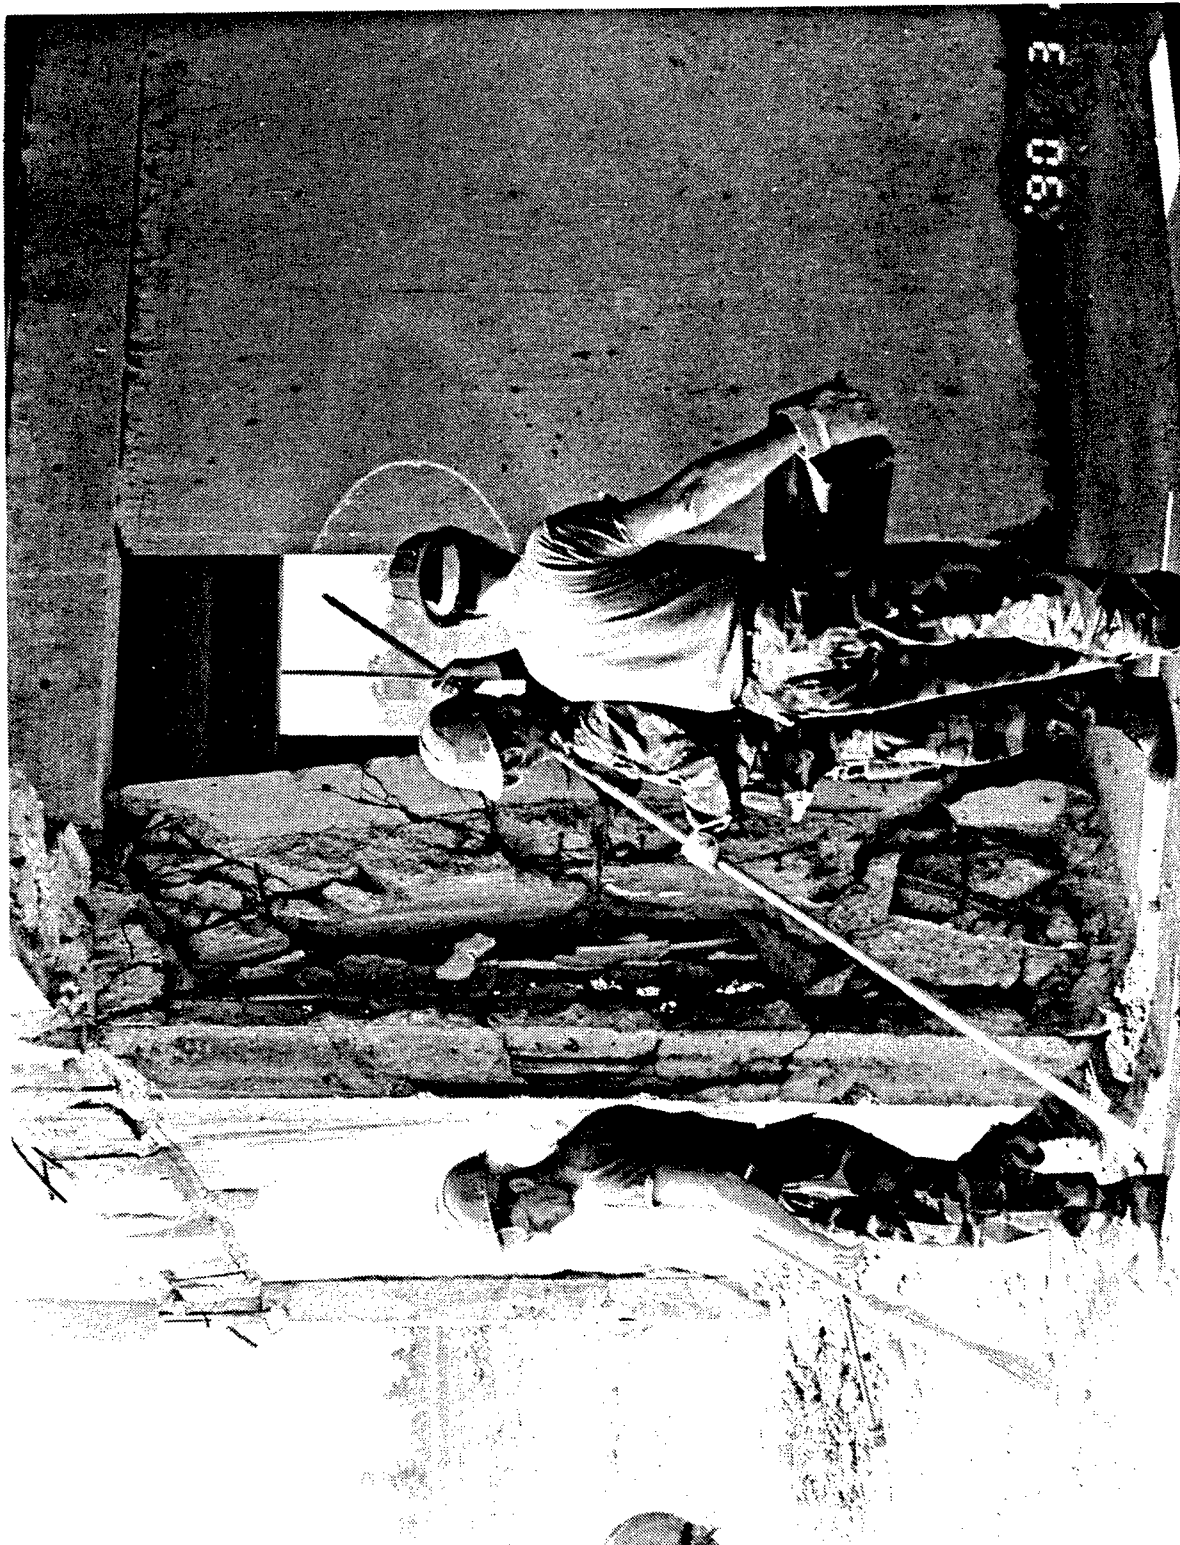
Figure 49. Height Measurement Next to Destroyed Column.

Views of the column replacement process are shown in Figures 48 through 55. Debris was cleared from around the column (Figure 48). A height measurement was taken next to the damaged column, to find the required replacement column length (Figure 49). The glulam column was then trimmed to the correct length using a chainsaw (Figure 50), while a shoring jack was placed next to the damaged column and extended by hand to refusal (Figure 51). The length of the glulam column was trimmed to leave a 1/2-inch gap between the top of the column and the bottom of the roof beam. This allowed wooden wedges to be inserted between the column and the roof beam to firmly secure the column in place. The glulam column was then positioned next to the shoring jack (Figure 52), and the wedges inserted (Figure 53). Lateral bracing consisting of two-by-fours was attached to the glulam column with nails, and anchored to two-by-fours secured to the concrete floor of the structure with ramset studs (Figure 54). Finally, the shoring jack was removed (Figure 55) completing the column replacement process.

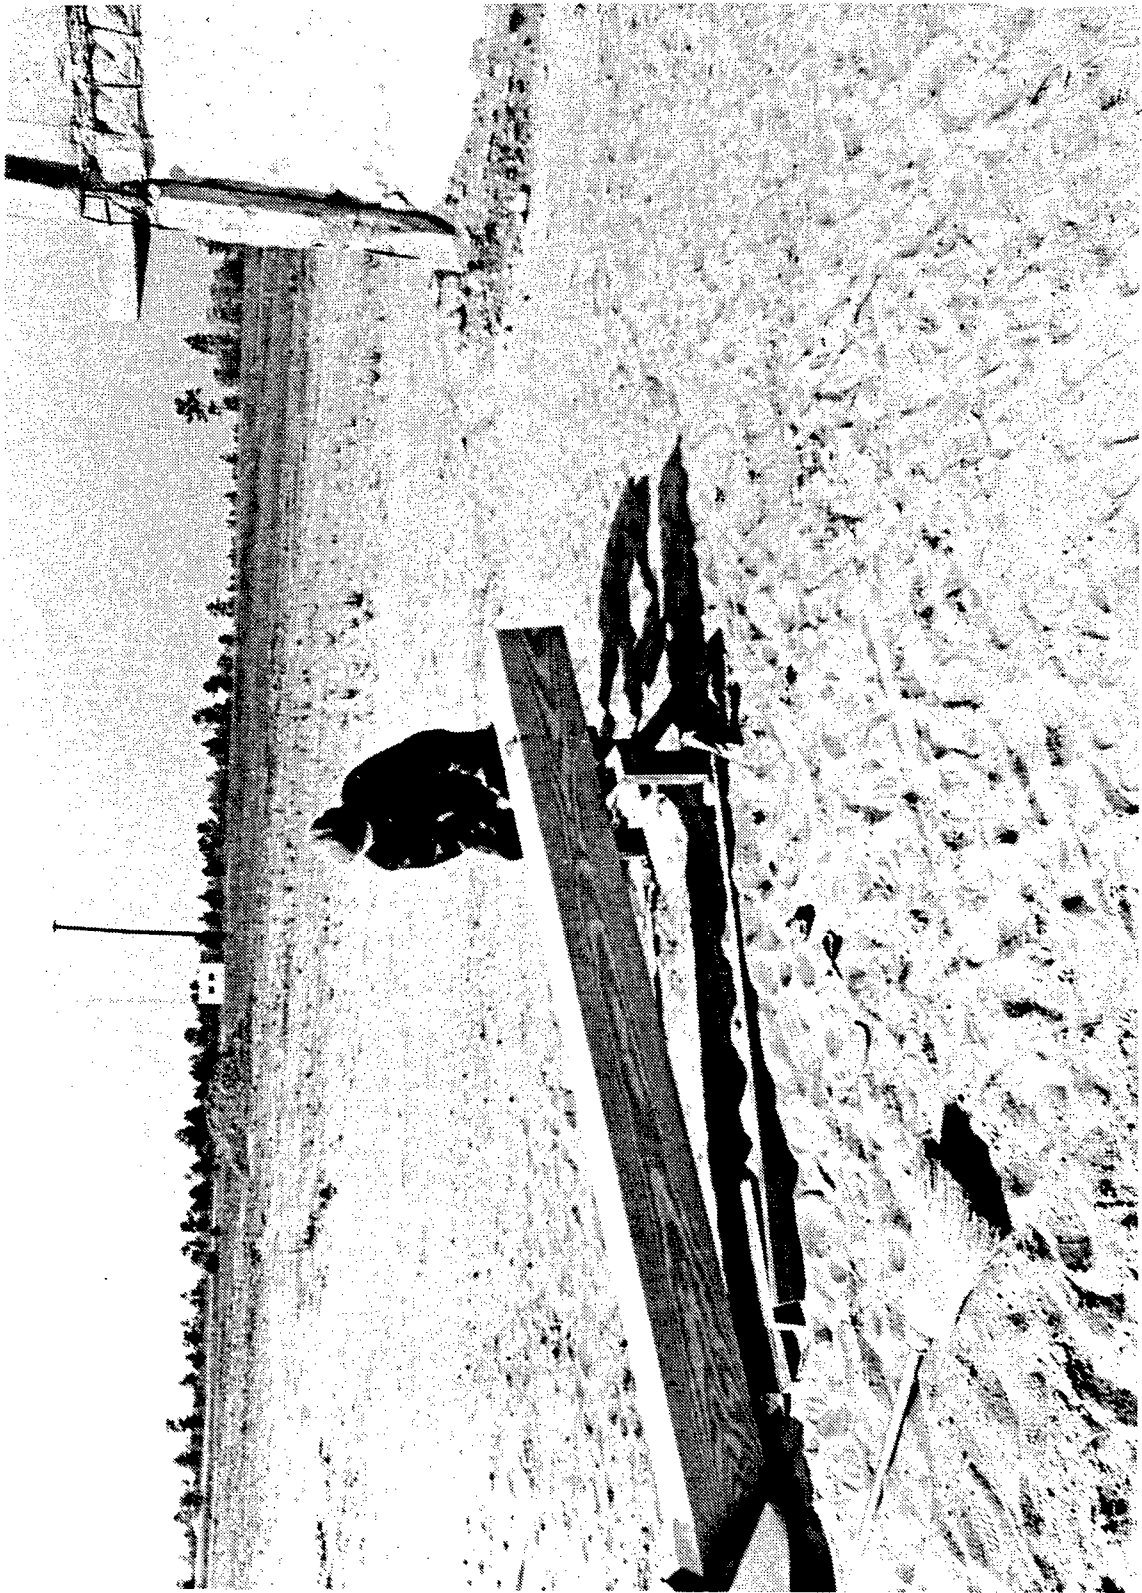
Figure 50. Trimming Glulam Timber Column to Correct Height.

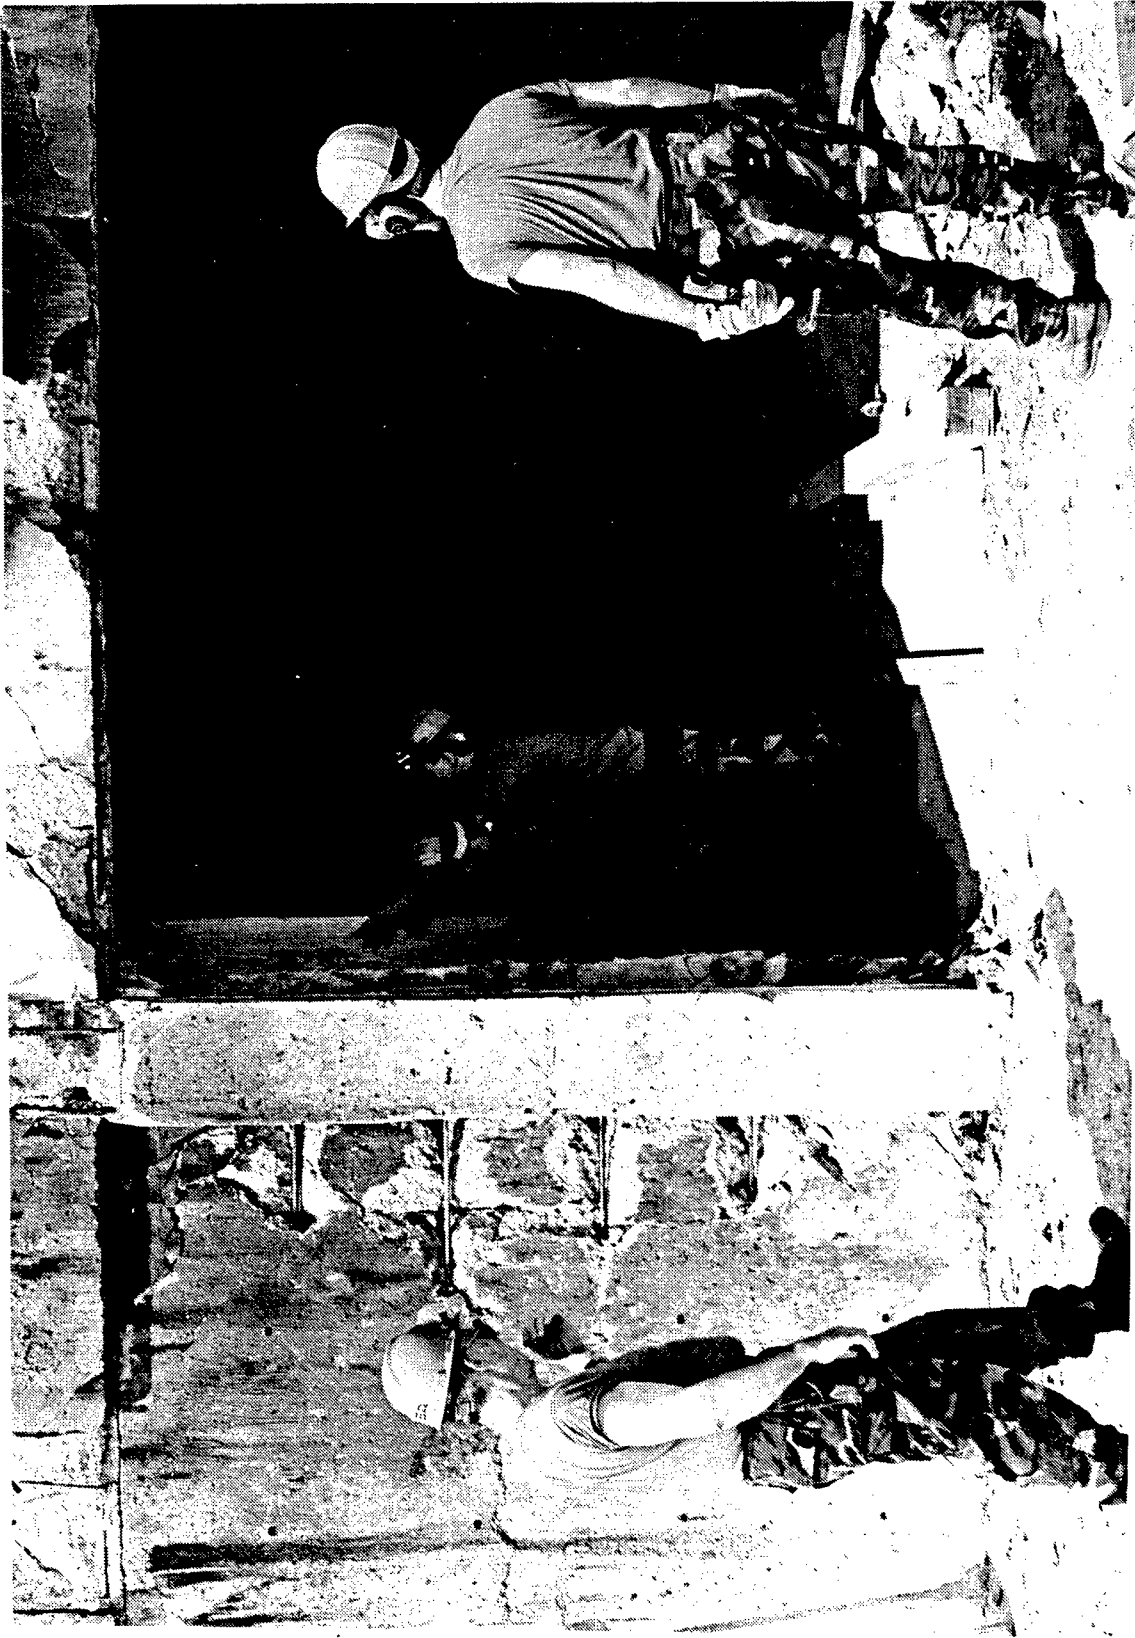
Figure 52. Placing Trimmed Glulam Timber Column Next to Shoring Jack.

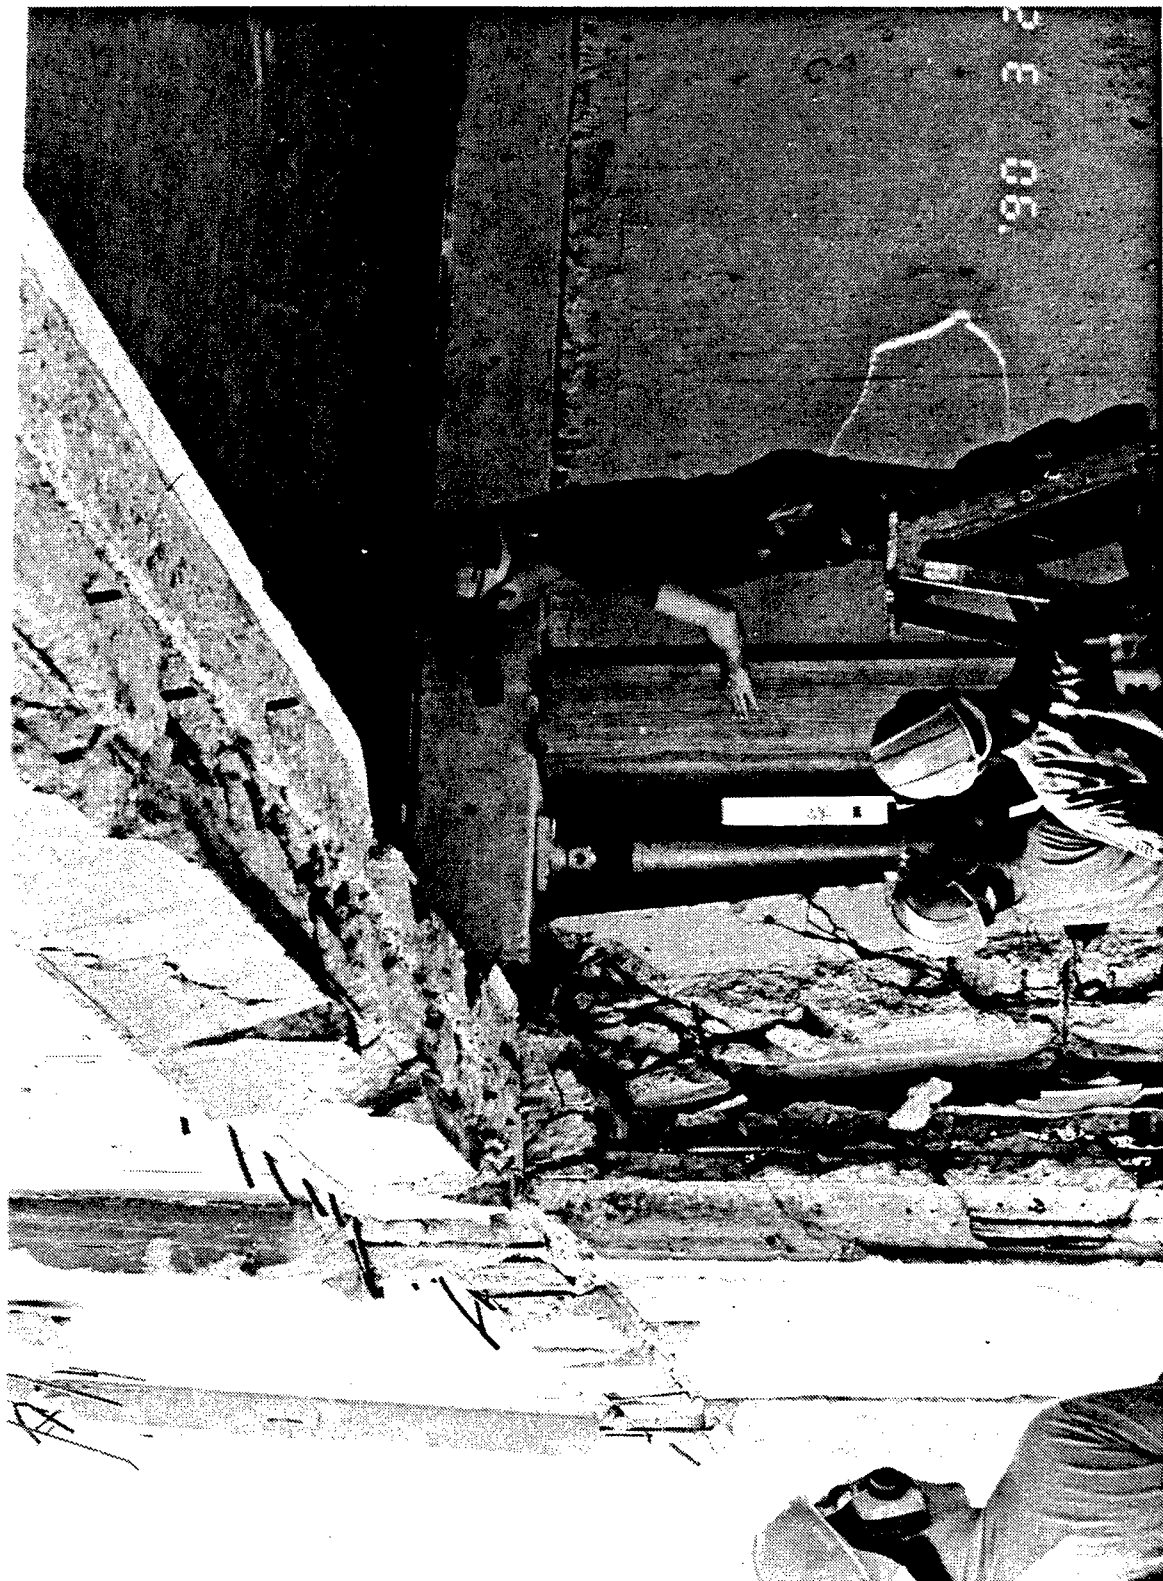
Figure 53. Inserting Wooden Wedges Between Replacement Column and Roof Beam.
